LOWER HEREFORD MANOR DAM

NDI I.D. NO: PA-261

PHASE I INSPECTION REPORT
NATIONAL DAM INSPECTION PROGRAM

D'APPOLONIA CONSULTING ENGINEERS

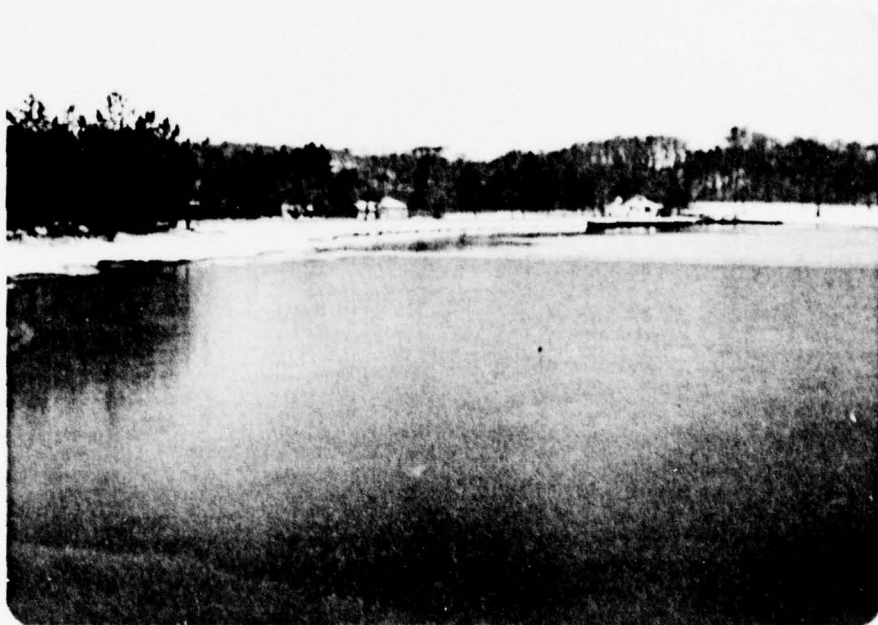
Upstream Face

While a portion of the upstream slope is protected by a masonry wall against erosion, the remaining portion of the upstream slope has no riprap. At certain sections, the upstream slope is steep (approximately one horizontal to one vertical).

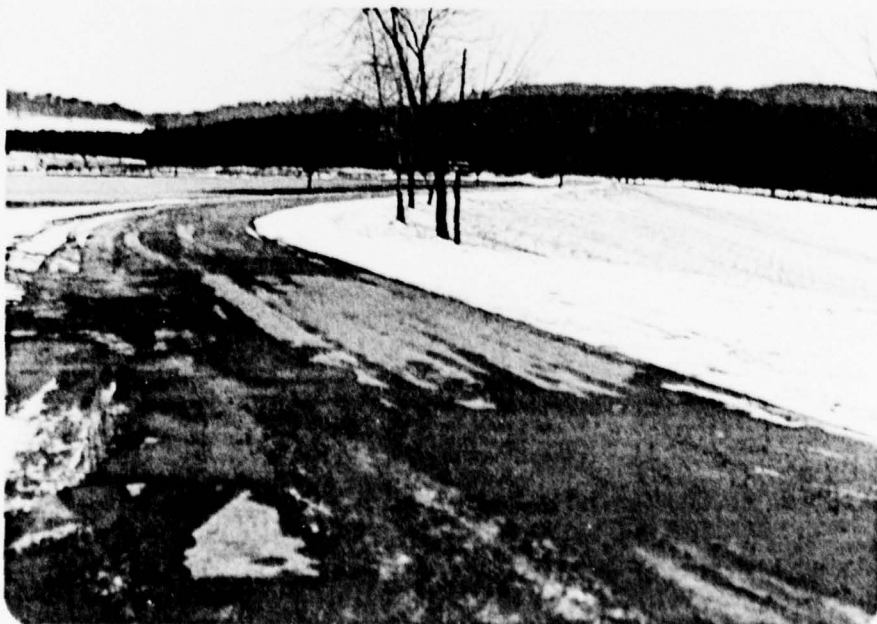
Downstream Face

In general, the condition of the embankment is considered to be fair. One wet area and a seepage point were found on the downstream face of the dam. The wet area was located near the left abutment approximately midheight of the downstream slope. No seepage flow appeared to be associated with this wet area. Seepage was found in a ditch on the downstream slope of the dam. The flow was estimated to be on the order of four to five gallons per minute.

5. The crest of the dam should be surveyed and low spots filled to design elevation.
6. The seepage on the downstream face of the dam should be periodically observed and remedial action taken if conditions deteriorate.

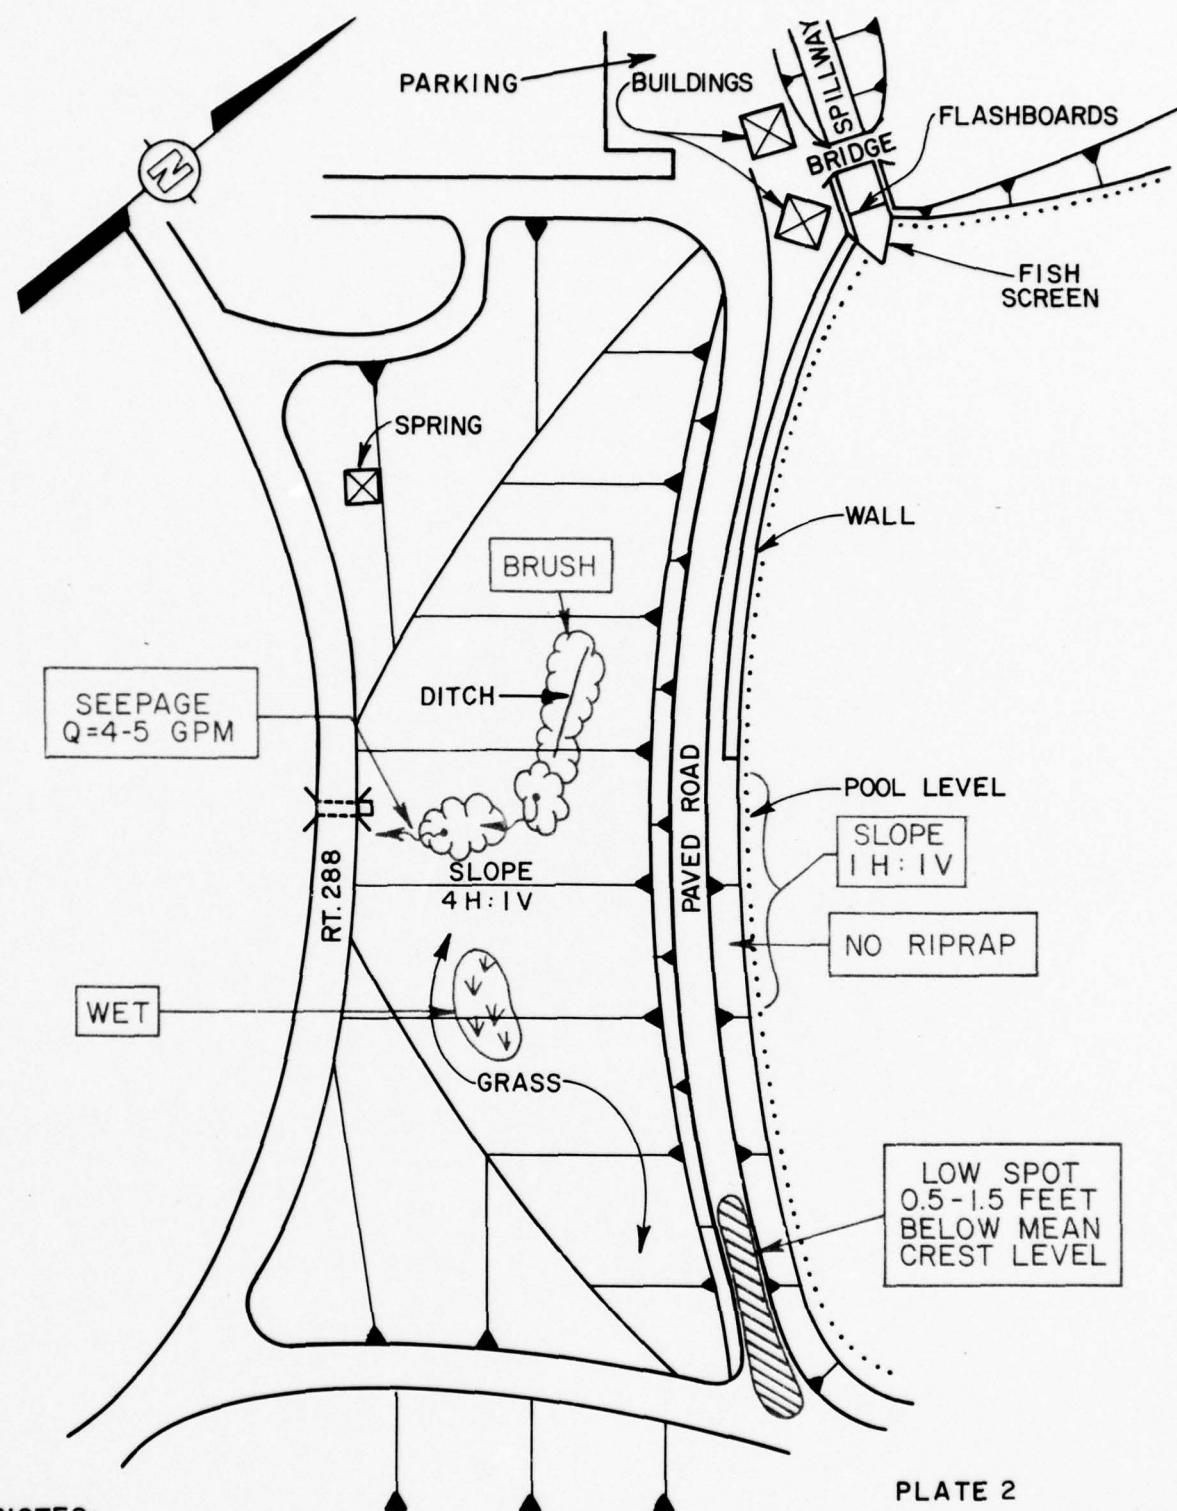
1. SPILLWAY FREEBOARD
(MEASURED FROM LOW SPOT ON
CREST TO TOP OF FLASHBOARDS = 2 FT.
2. POOL LEVEL DATE OF INSPECTION:
1.3 FT. BELOW LOW SPOT IN CREST.

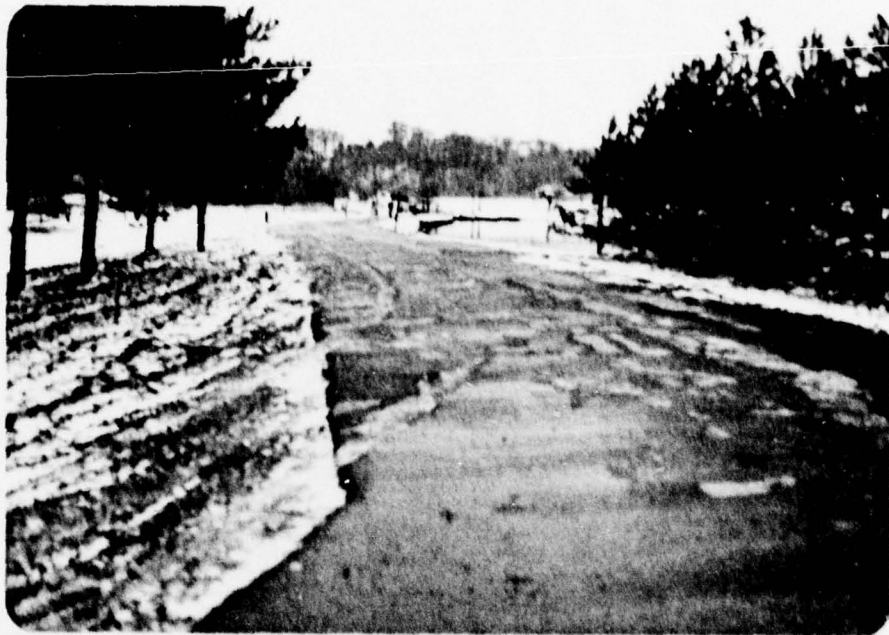
The top of the embankment was surveyed relative to the spillway flashboard crest elevation (934.7). A 150-foot-long section of the crest near the left abutment was found to be 0.5 to 1.5 feet below the mean crest elevation. The lowest point was about two feet above the spillway flashboard crest level.

Photograph No. 1
Crest (looking west).

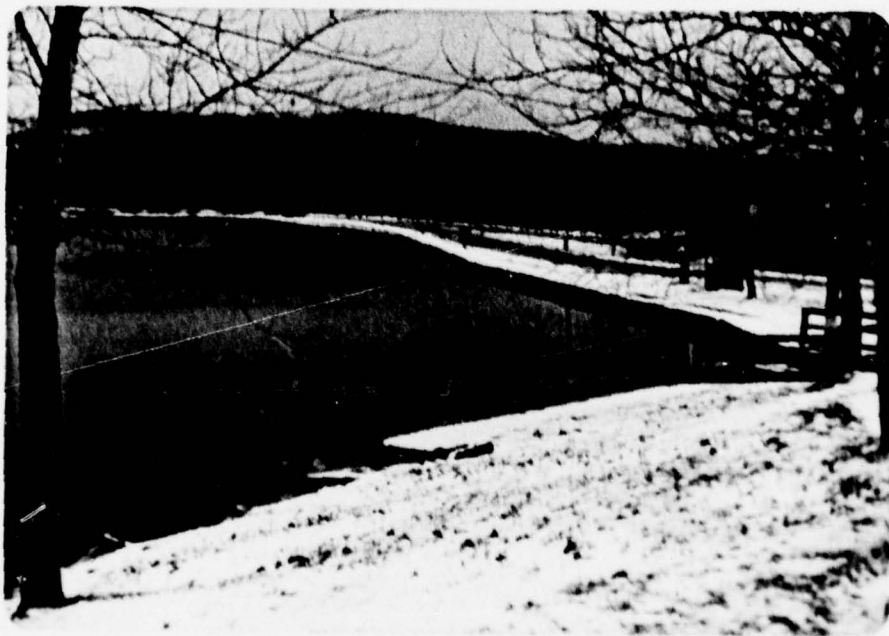
c. Appurtenant Structures. The only appurtenant structure of the dam, the spillway, was examined for deterioration or other signs of distress or obstructions that would limit flow. The fish screen, located immediately upstream of the flashboards, was found to be partially clogged by debris. The pool level of the upstream side of the fish screen was approximately eight inches higher than the water level on the downstream side of the fish screen. This condition clearly demonstrates the potential for obstruction of flow through the spillway by debris accumulating on the fish screen.

Photograph No. 2
Spillway approach. Spillway crest behind wood fence.

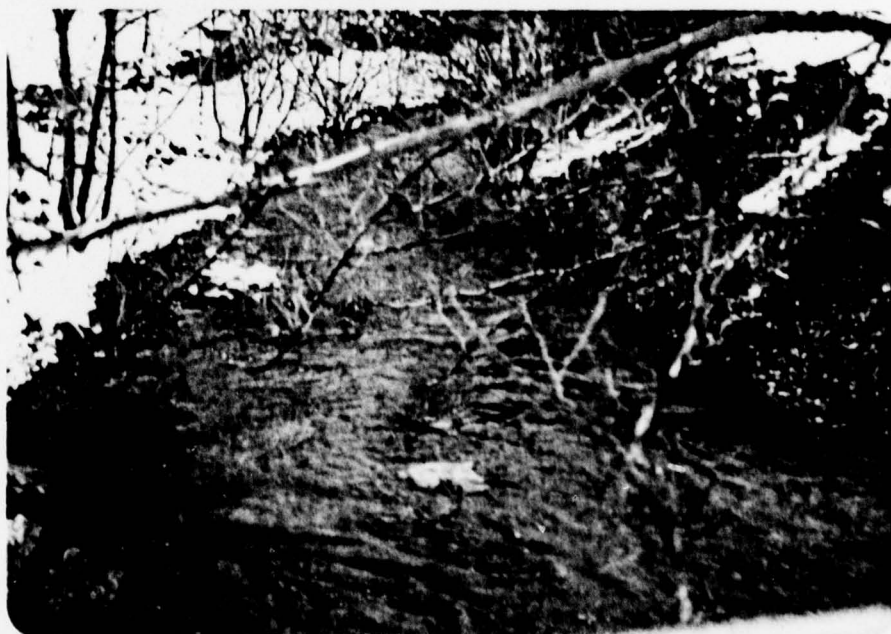
Photograph No. 4
Spillway discharge channel (looking downstream).
